## Chapter 8

### Working Safely near Energized Overhead Powerlines

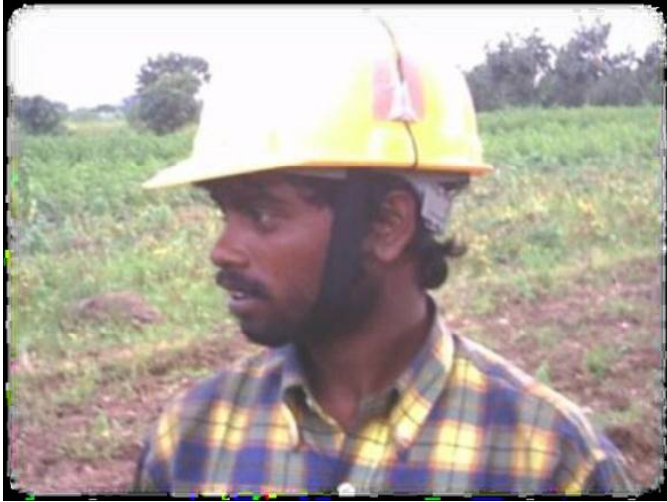
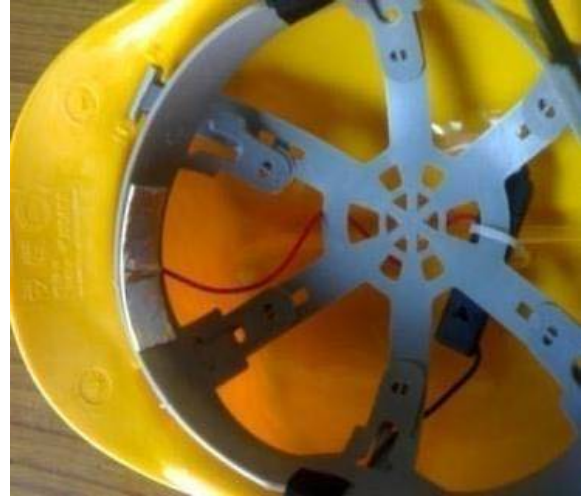
Induction sensors placed inside the helmet

Subsequently a sensor based alarm system was installed inside the safety helmet which was provided to workers in the vicinity of energized power line 300 sample measurement were taken to check the effective and functioning of the device installed and the following mean values were arrived for the alarm:

<b>N = 300</b>			
Voltage in kV	66	11	33
Required distance in m	19	275	36
Alarm from sensor fitted in Helmet	2	36	4

A survey of 30 such hazardous work locations involving 200 to 300 crew members indicated success of the devices including reported life-saving incidents which can be projected to 3 per million of man-hours worked
